Assab Referral Hospital Construction

PREPARED BY
MESFIN TEWOLDE

Assab Referral Hospital Construction
[June 2000- Early 2006]

1. ASSAB REFERRAL HOSPITAL CONSTRUCTION

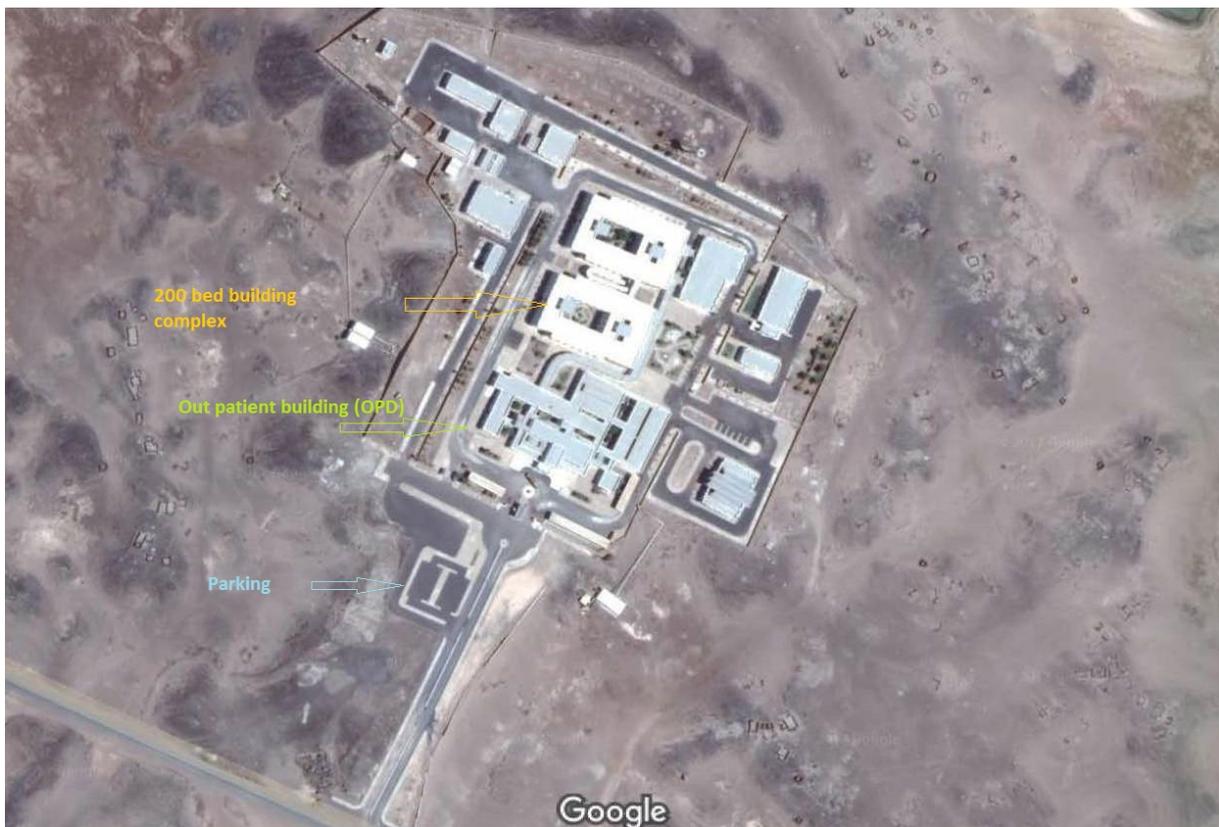
Figure 1 demonstrates a bird's eye view of Assab hospital facility.

Figure 1 Building complex of Assab referral hospital.

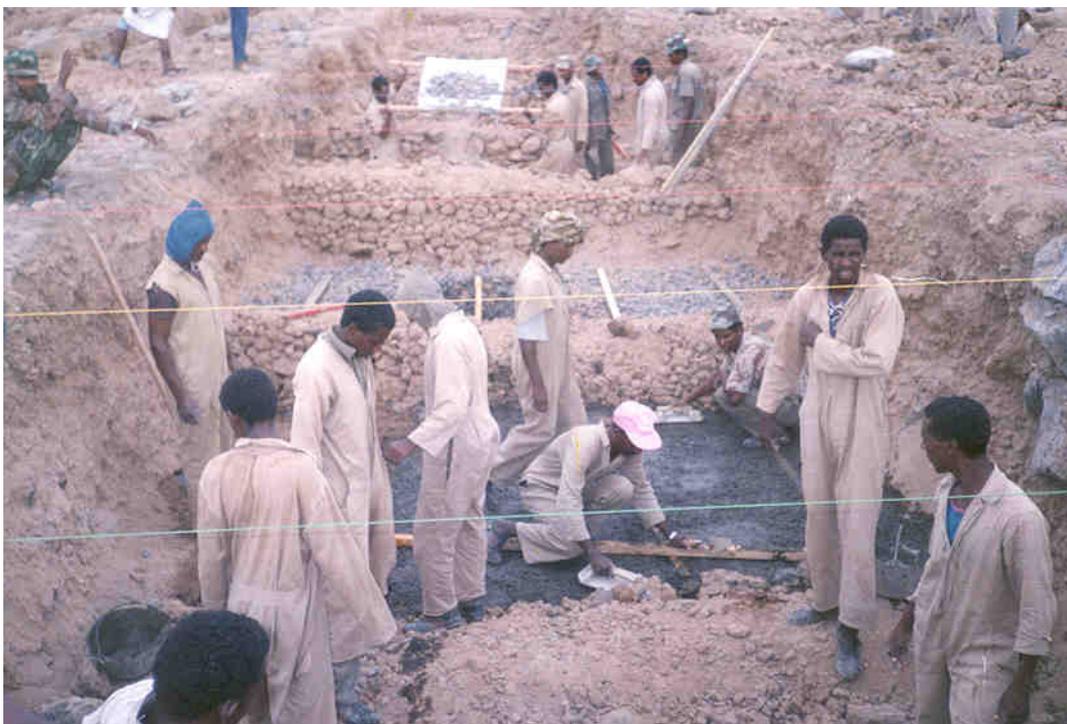
5 cm deep lean concrete were cast before the foundation formwork placed. Figure 2 shows the lean concreting at Assab hospital construction site.

Figure 2 Lean concreting at Assab construction site

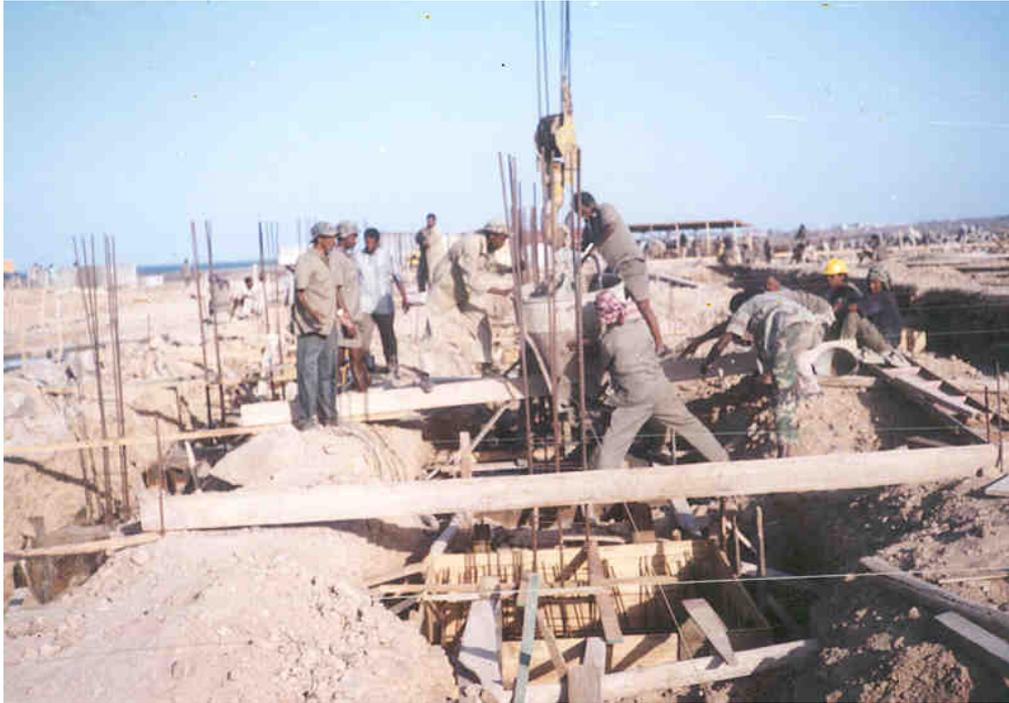
Mainly because the geological formation of the site was rocky and robust, the excavation depth did not actually need to be greater than 1.5 to 2m depth. The kind of the foundation utilized for the site was a Spread footing foundation with an individual foot size of around 120m*85cm and 45 cm depth. The girder beam and all the columns were cast in-situ.

Figure 3 Constructing the foundation and columns of Assab referral hospital

Figure 3, 4, and 5 demonstrate foundation and columns placement at the Assab hospital construction site.

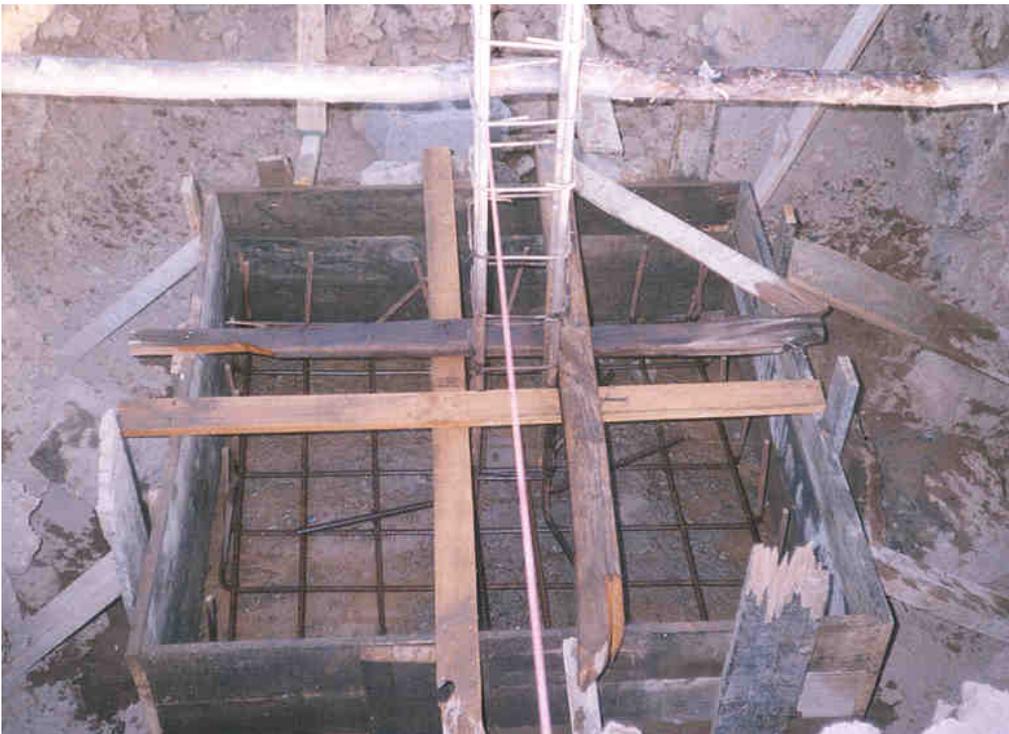
Figure 4 Single spread foot foundation utilized at Assab hospital

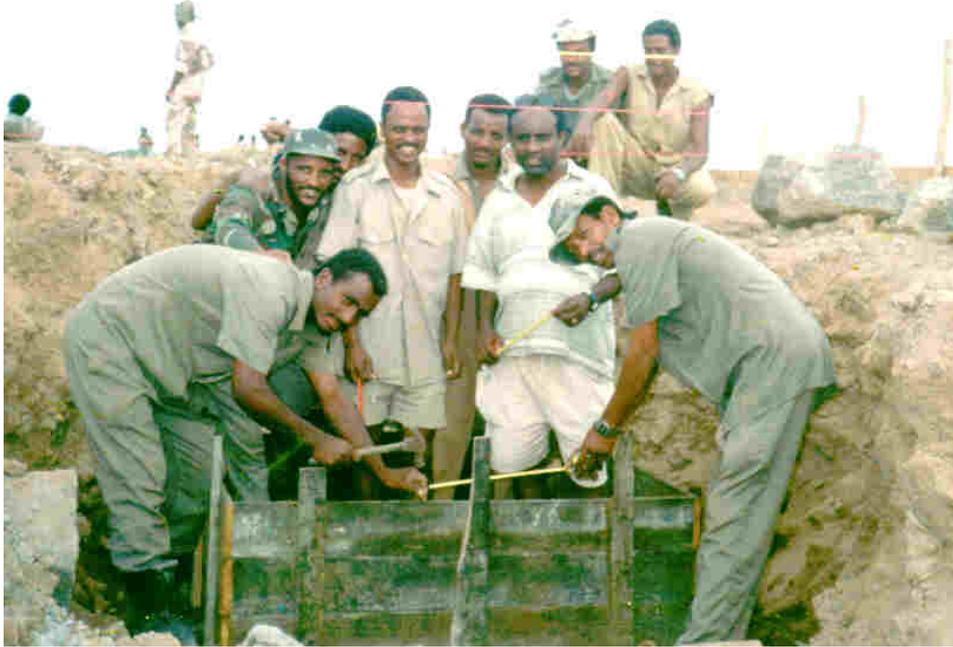
Figure 5 Foundation formwork placement

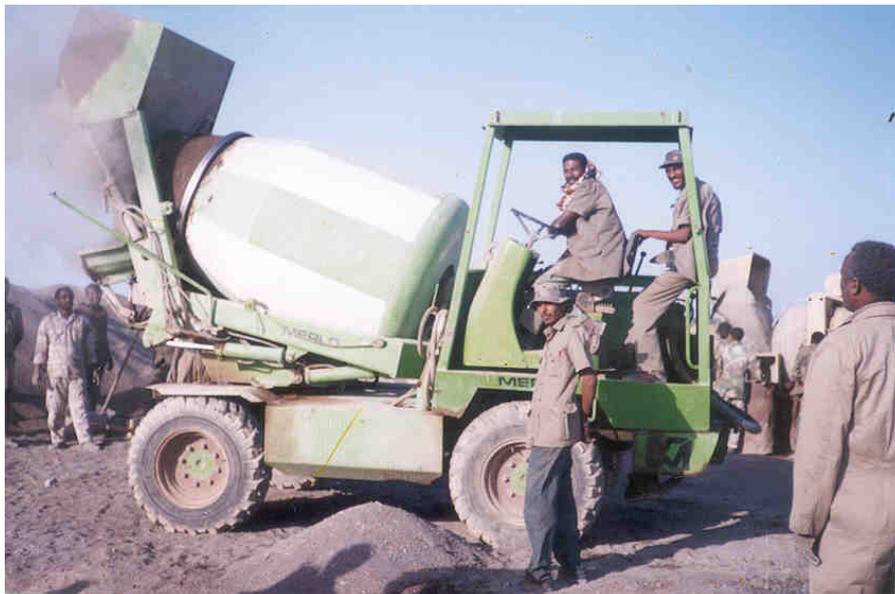
The standard mortar mix employed was B25, and for the foundation, beam, and columns concrete mix implemented with identical mix ratio. Which is a mix ratio of cement: sand: gravel of 1:2:4. Figure 6 shows concrete mixing machinery utilized at Assab hospital.

Figure 6 Movable concrete mixer utilized at Assab hospital

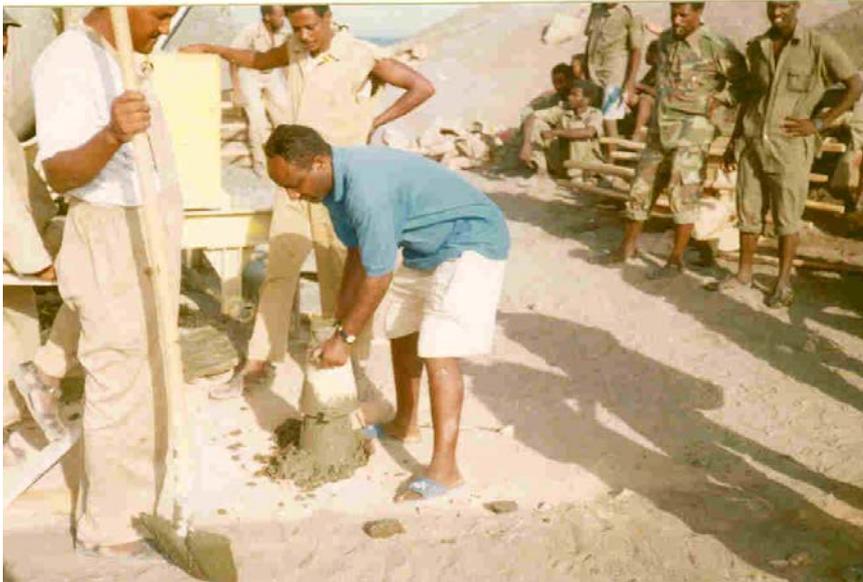
Standard Concrete mixing procedure was considered for this construction and the concrete pastes were inspected employing a fairly easy method known as slump test technique. Examining the concrete mix consistency is essential simply because it assists to prevent the effect of excess water in the mortar or concrete mix. The presence of excessive water can damage the structures as it simply leaves cracks in the building as soon as the water evaporates. Later, this will likely bring deterioration to the reinforcement bar, eventually causing untimely failure. Hence, validating the concrete consistency is actually vital to avoid cracks in the building. Figure 7 shows the slump test procedure.

Figure 7 Slump test

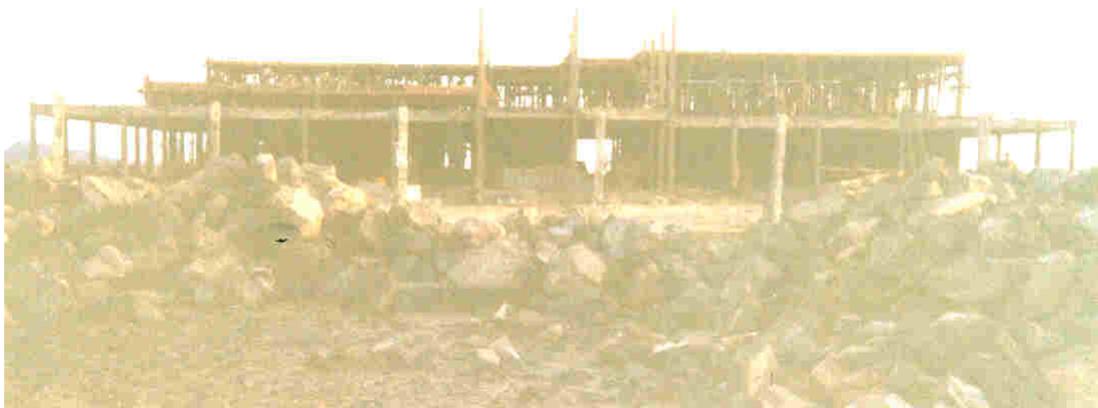
Figure 8 and 9 shows the skeleton of the OPD

Figure 8 Outpatient department construction in progress

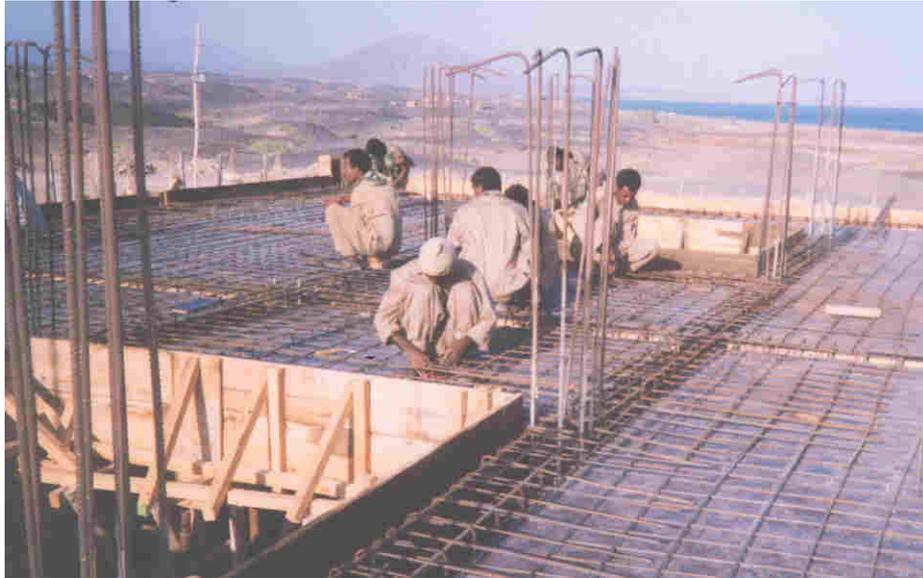
Figure 9 First floor reinforcement placement

The first floor is 15 cm thick reinforced slab. It has got a terrace at the left corner of the building for outdoor lounging. The roofing, similar to the roof, it is 15 cm thick concrete slab. Besides that, there exists a 50 cm parapet wall above the rooftop. Figure 10 shows the completed OPD building.

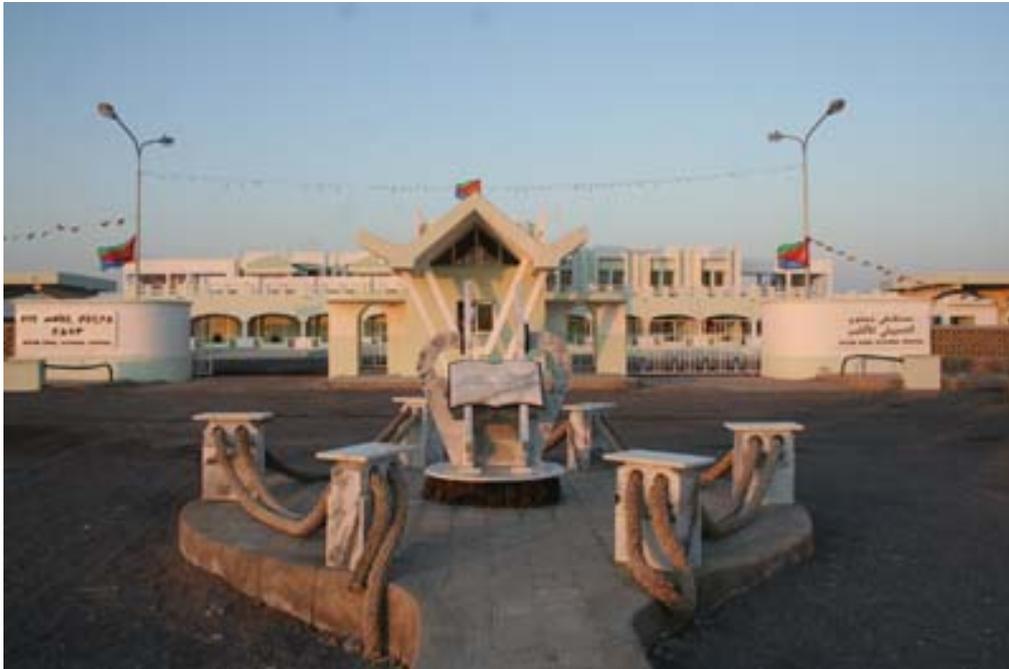
Figure 10 Assab referral hospital completed OPD building
