## HEC-RAS ANALYSIS: RIVER L'AÏRE, GENEVA, SWITZERLAND

Flood Risk Assessment and Bank Stabilization Strategies  
for Sustainable River Management

Mesfin Hagos Tewolde [EUR ING, PE]  
H&S ENGINEERS

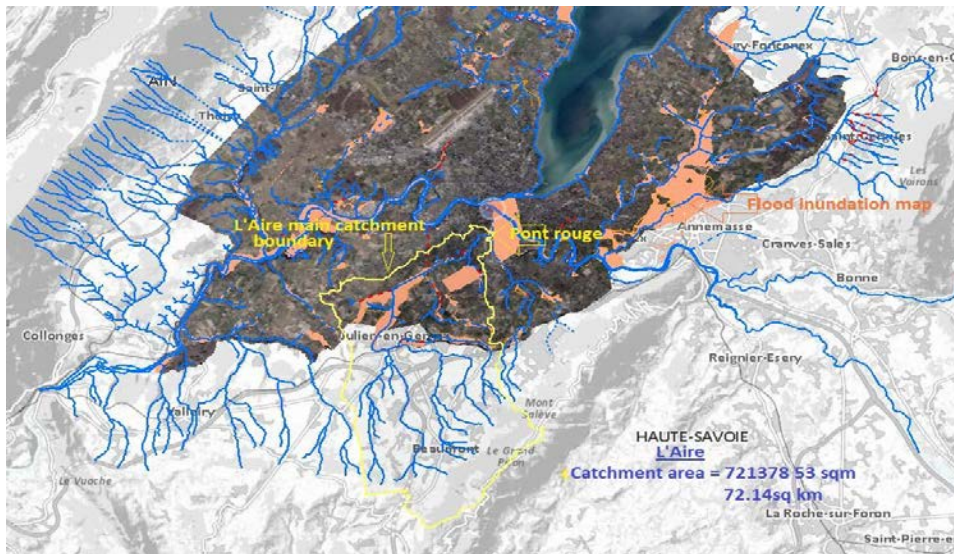
Figure 1 Catchment and watercourse of L'Aire.

The River L'Aïre originates from the outskirts of Presilly, Beaumont, and Feigères in France, merging at St. Julien en Genevois before flowing into Geneva. It passes through areas like Confignon and Lancy, eventually joining the River L'Arve. The study area includes a 5.36 km stretch of the river with diverse landscape features, as shown in Figures 1 to 6.

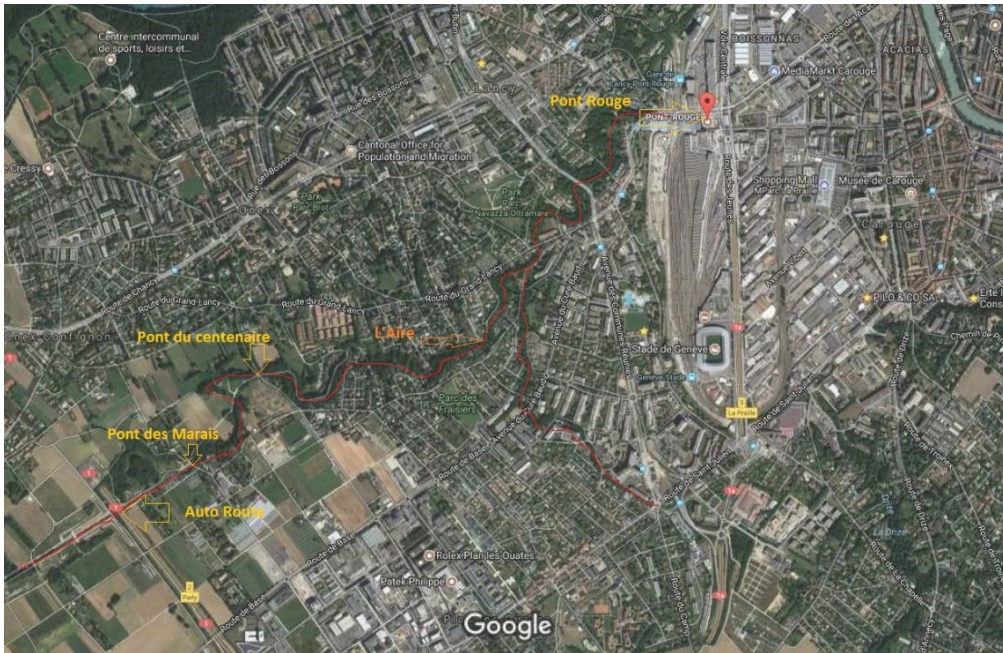
Figure 2 The river reach (5.36km).

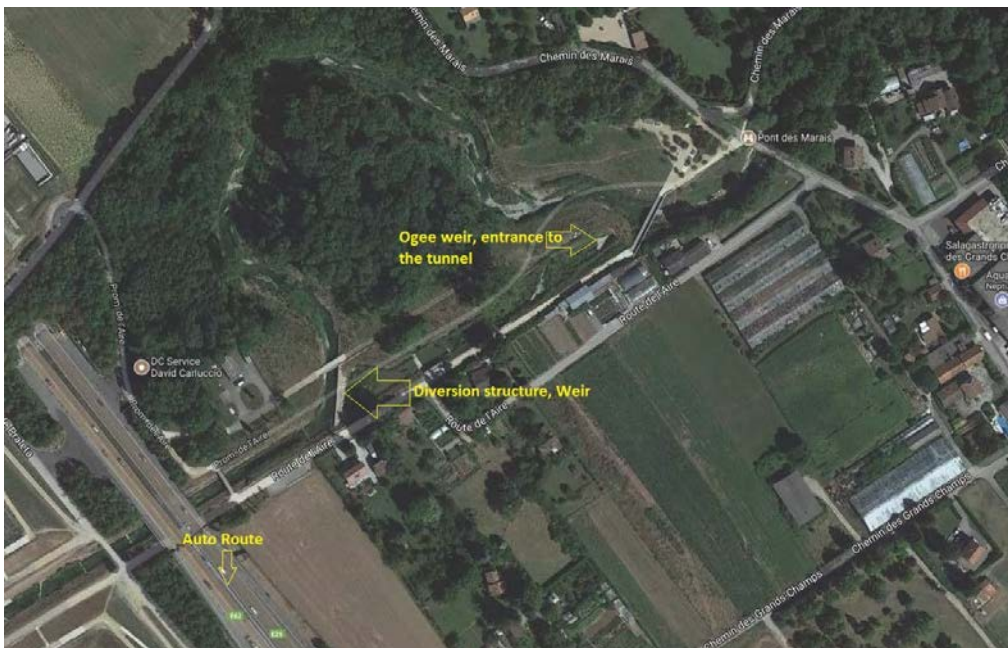
Figure 3 Newly constructed diversion structure and tunnel.

As the highest possible discharge that can be taken care of at the Pont Rouge (tunnel entrance) is 60 Cumec, lowering the discharge below 60 Cumec is essential. The new construction work of the diversion structure reduced effectively the amount of discharge at the Pont Rouge. The result of this HEC-RAS analysis has also demonstrated the same.

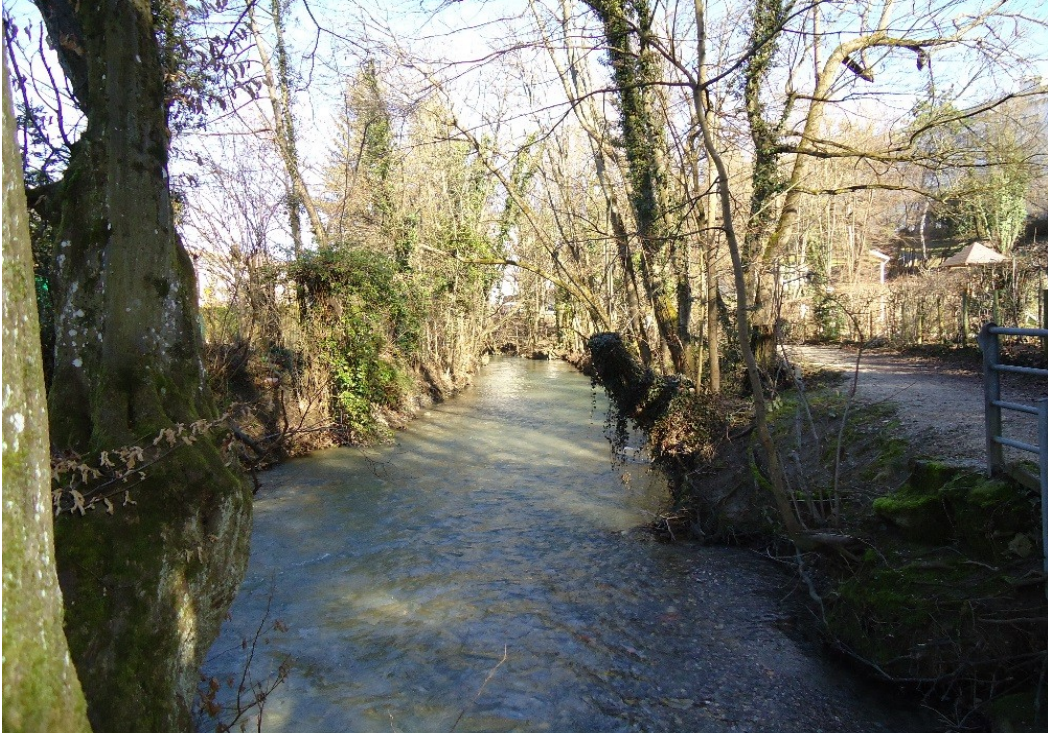
Figure 4 Vegetation covers around 2.8 km of the Pont-Rouge (photo taken on 4.03.2014).

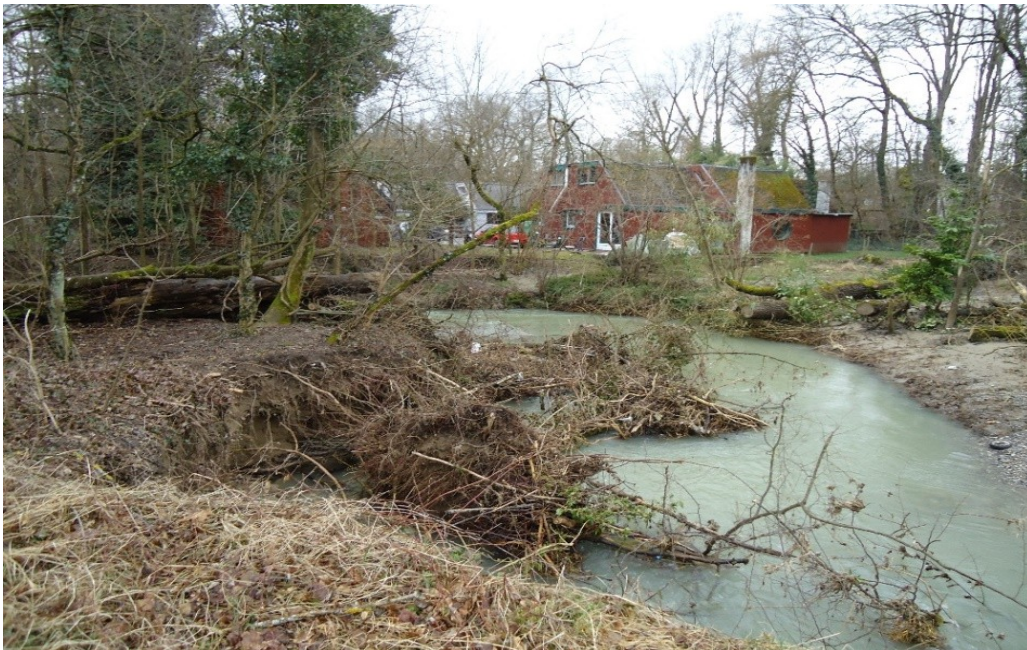
Figure 5 Eroded bank at around 4km upstream of the D/S end (Photo taken on 4.03.2014).

Along the River Aïre many stabilization measures exist. For instance, one can see biological or organic protection as a measure to protect further degradation of banks. Moreover, certain gabion protections exist. Nevertheless, there are still spots where bank stabilization is needed. As it is pointed out in Figures 5 and 6, river-bank curvatures are prone to erosion and require protection. Construction of levees, temporary or provisional flood storage basins, and sometimes elevating the village above the flood line are some of the precautions that need to be implemented to alleviate future potential mishaps.

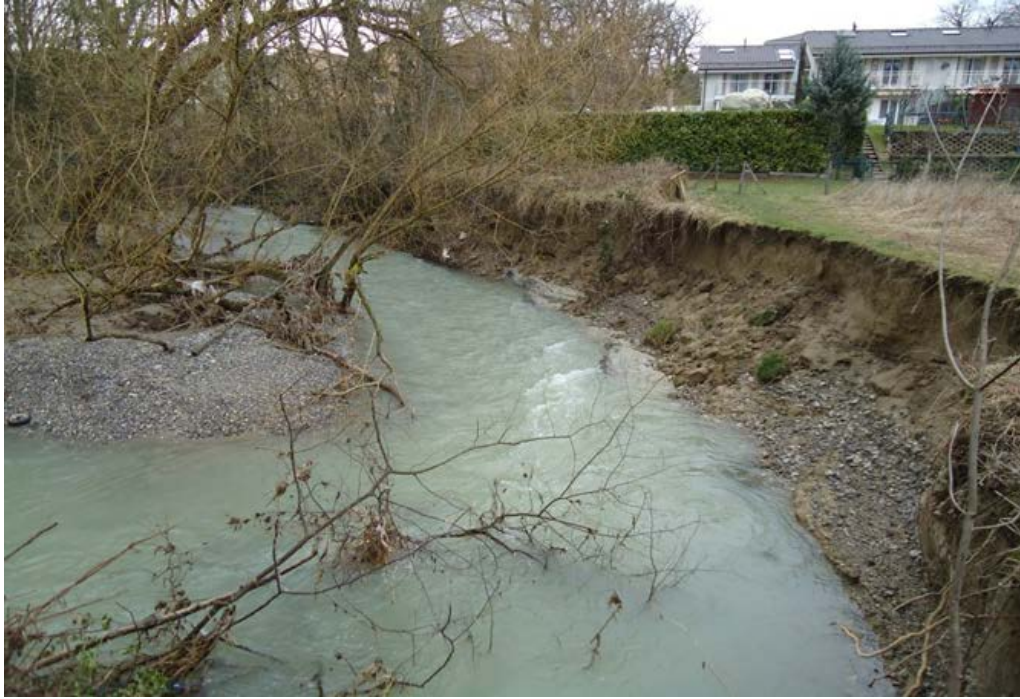
Figure 6 Unstable bank at around 4km of the D/S end (Photo taken on 4.03.2014).

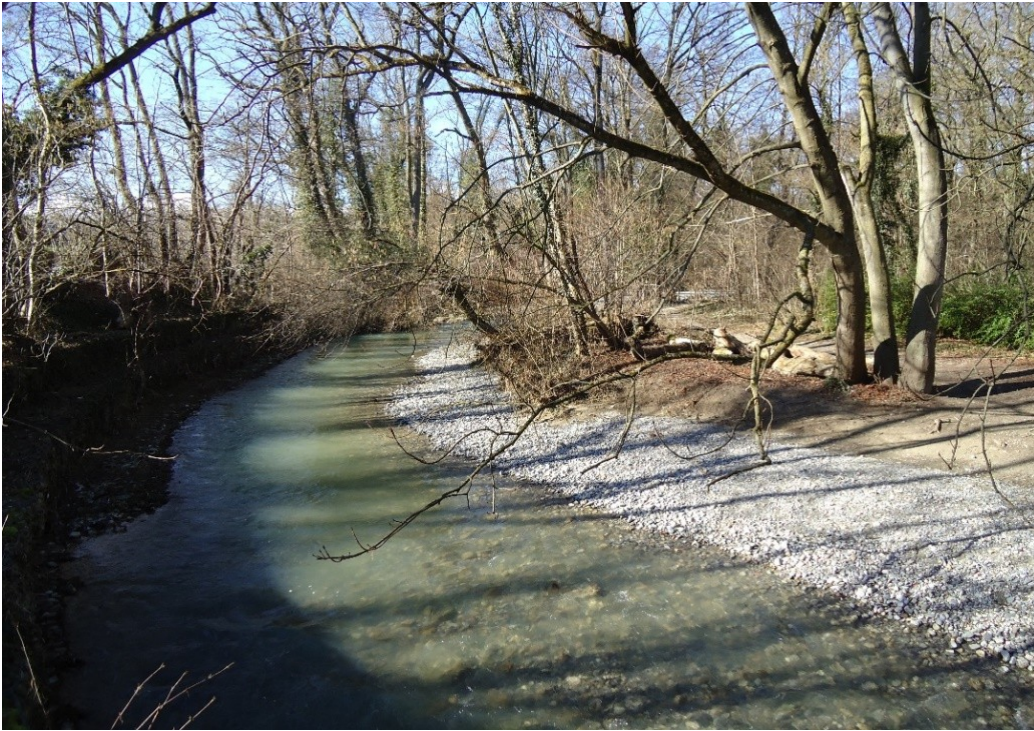
Figure 7 Cobbles along the main riverbed.

The analysis utilized cross-sectional and hydrological data, though the data source was not clearly specified. Corrections were applied where necessary to ensure model accuracy. The roughness coefficients were assumed to be 0.05 for riverbeds and 0.1 for banks, reflecting the presence of cobbles and vegetation. Flow measurements for four recurrence periods (Q10, Q30, Q100, and Q300) provided the basis for simulating hydraulic conditions. Flows for the given recurrence time periods are presented in Table 1.

Figures 7 and 8 indicate representation of the riverbed, the right and the left banks of the river.

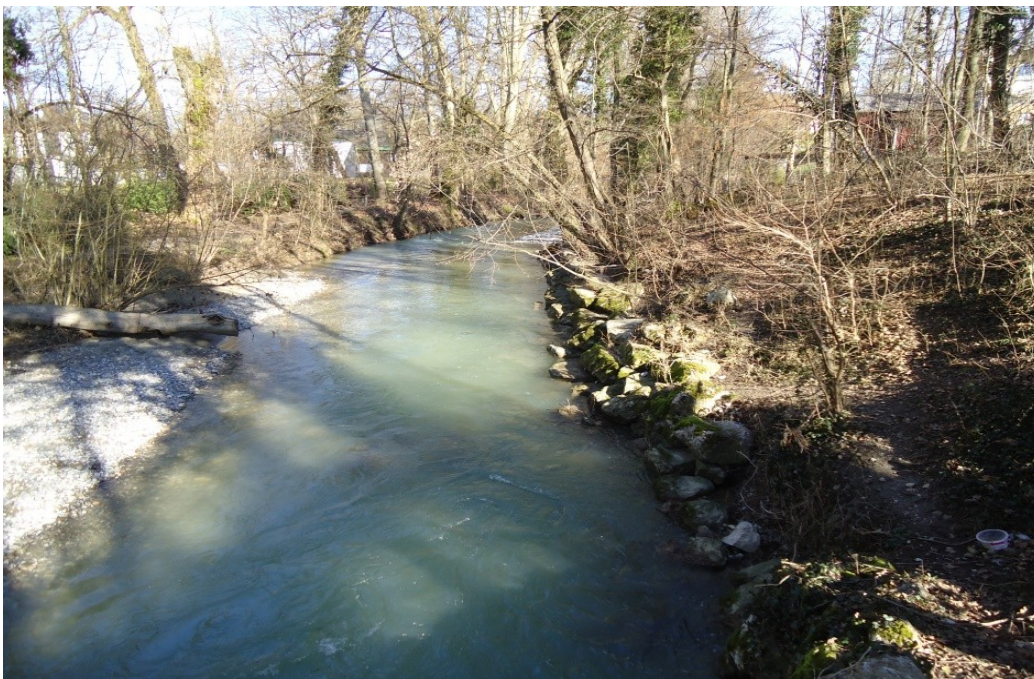
Figure 8 Vegetation covers along the river (represent 60-70%).

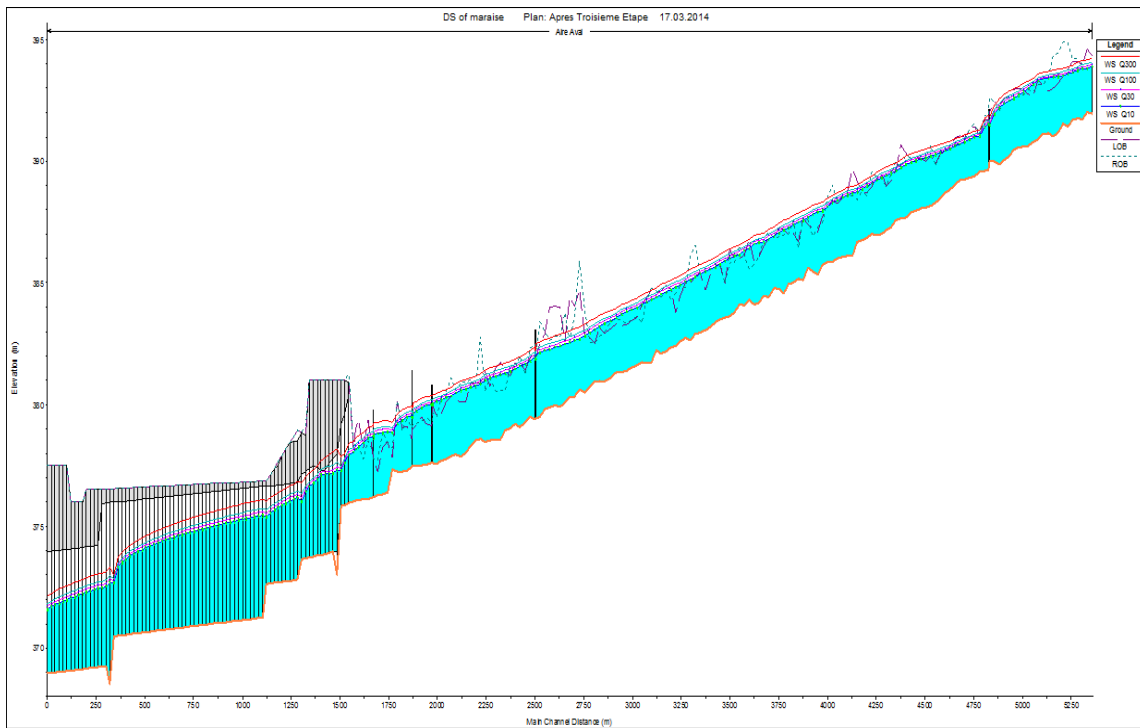
Figure 9 Longitudinal profile of the river for each return period.

The HEC-RAS simulations revealed flow velocities ranging from 0.63 to 3.95 m/s, with higher velocities causing significant erosion risks. At higher discharges, such as Q100 and Q300, inundation of adjacent areas becomes a serious concern. Protective measures like gabion walls, retaining structures, and temporary flood storage basins are essential to mitigate these risks.

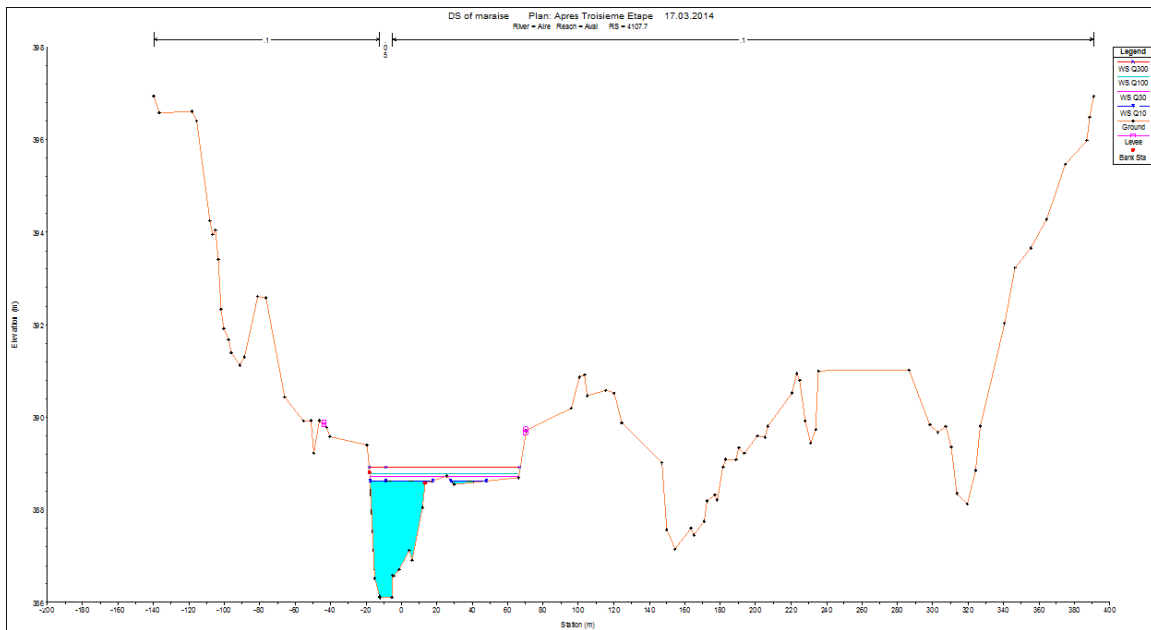
Figure 11 Cross-section at station 4107.7m.
